MONSANTO COMPANY UPPER DAM  
MA 00573

PHASE 1 INSPECTION REPORT  
NATIONAL DAM INSPECTION PROGRAM

OCTOBER 1978

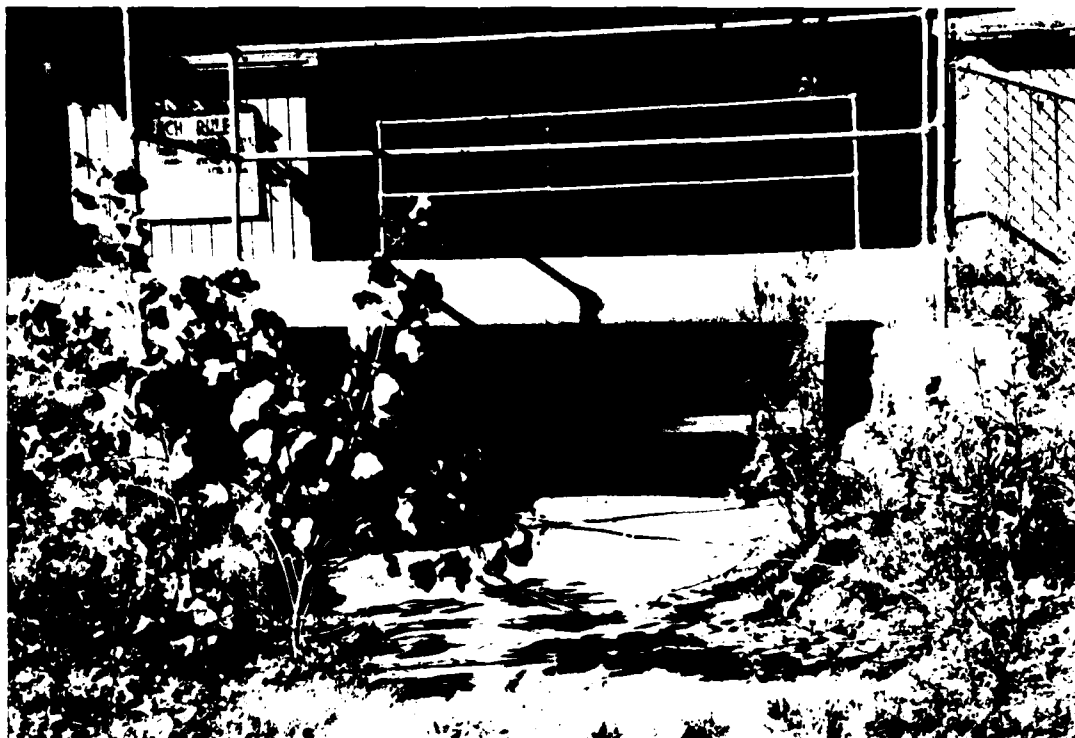
The spillway appears to be generally in good condition. The approach to the spillway apron is covered by sediment, has a few saplings and grass growing. (See Photograph No 4). The approach apron and spillway channel are covered with a bituminous overlay which is in good condition. The concrete floor of the spillway chute is heavily spalled with some minor debris on the floor. An anchor fence spans the entrance to the spillway chute. (See Photograph Nos 6 & 7). The bottom of the fence is 14 inches above the chute floor, but is equipped with a hinged section, which when raised, provides a clear opening of 26 inches. The spillway

4. VIEW OF SPILLWAY ENTRANCE. NOTE VEGETATION.
